Performance of Outdoor Wireless Internet Micro-Hubs

Andrew J. Farris, Matthew J. Traum
Mechanical and Energy Engineering Department, College of Engineering
University of North Texas

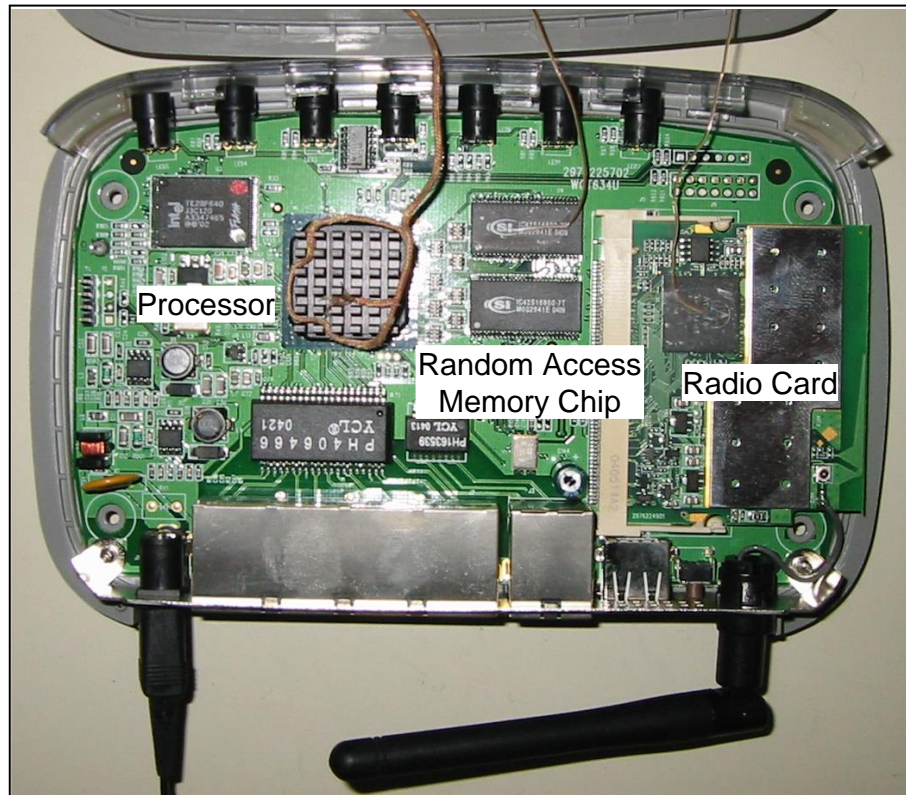
The failure temperature of a router node is the temperature at which the router ceases to emit a wireless signal. A sacrificial node was selected at random from a lot of Netgear WGT634U routers supplied to UNT by Roofnet. This node was instrumented with three Omega 5SC-GG-K-30-36 K-Type thermocouples read via an Omega HH147 hand-held data logging thermocouple reader. The three thermocouple beads were placed in physical contact with the router processor, radio card, and random access memory (RAM) chip, respectively (the three thermocouple wires are visible in Figure 1). For the processor, the rigidity of the thermocouple wire was used to insure physical contact, but the thermocouple bead was not soldered or otherwise physically connected to the processor. Scotch® tape was used to affix thermocouple beads to the other router hardware components. The processor, radio card, and RAM chip were specifically selected for temperature interrogation because failure of any of these critical elements would cause the router to cease functioning. With the thermocouple beads in place, the plastic case was secured back into the router.

Figure 1. Thermocouple Instrumentation Scheme to Measure Component Internal Temperatures within Netgear WGT634U Wireless Router.

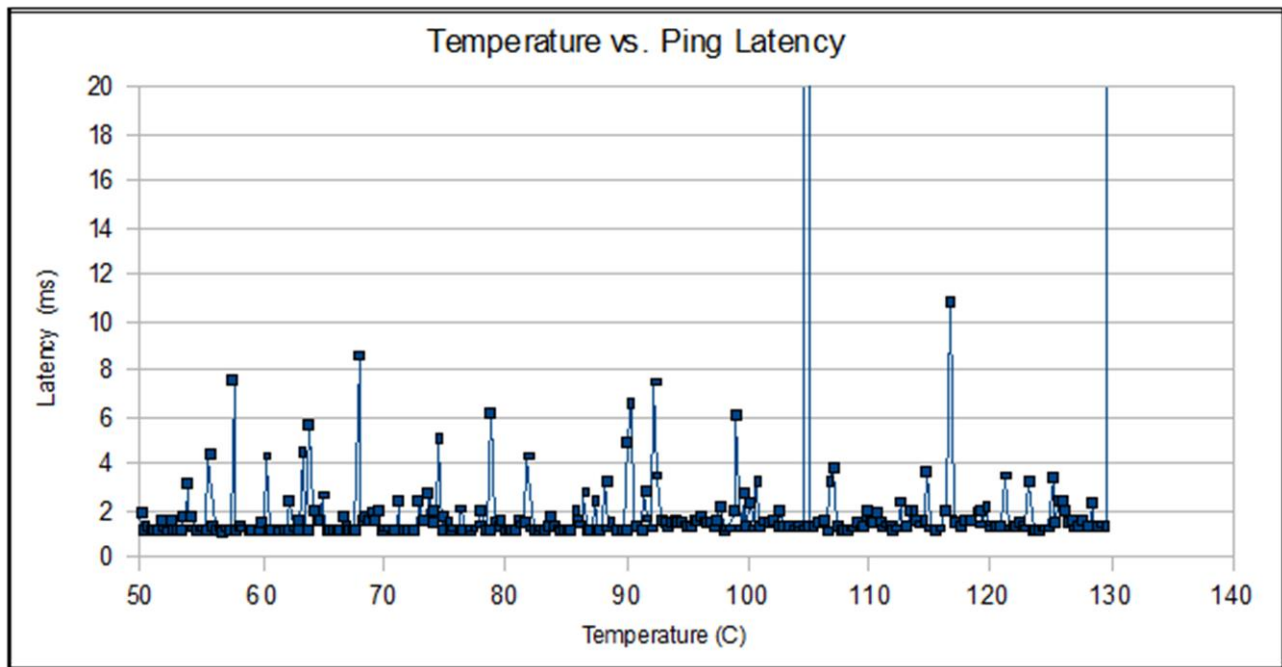
The solid-state router component that stopped functioning first owing to high temperature was the processor. Had the radio card failed, the router would have been seen to visually continue to function (i.e., the lights on the front panel would have continued flashing), but no wireless signal would be received by the laptop. Had the RAM failed, the router would have exhibited erratic wireless signals and packet loss prior to total failure. Processor failure should have resulted in total, instant router shut-off accompanied by simultaneous loss of wireless signal. This behavior is, in fact, what was observed, as is shown in Figure 2. The wireless signal's fidelity, or 'ping time,' remained a nearly linear up to the point of failure.

Figure 2. Ping Latency Versus Temperature during Netgear Router Heating. Vertical Lines on the Graph Indicate Dropped Packets, where the Latency was Recorded as Infinity.

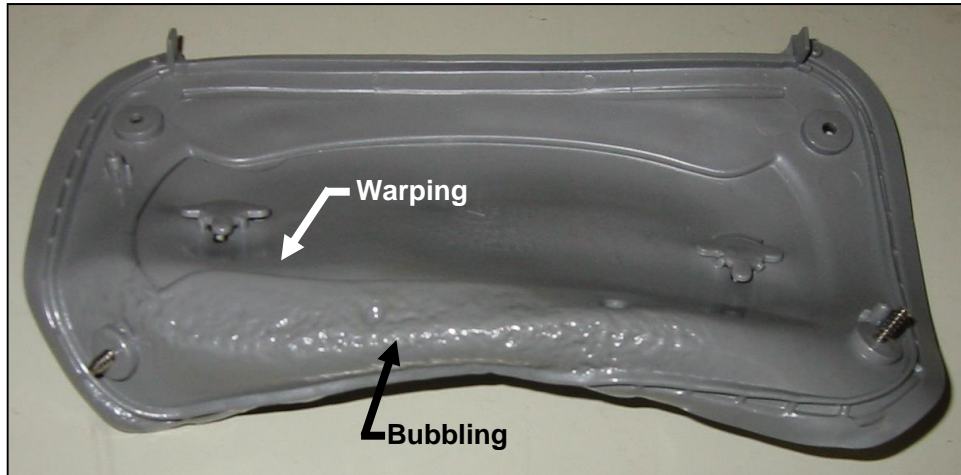
The Netgear WGT634U router processor failed at 130 ± 3 °C. Once the router was removed from high temperature and allowed to cool, however, it began to function normally again. So, irreversible hardware damage did not occur at 130 °C. Visible, irreversible hardware failure occurred at a processor temperature of 140 °C (the ambient temperature inside the oven was 156 °C) when the router's antenna burst, completely negating the node's wireless transmission capabilities.

The router's external plastic case began to melt at a processor temperature of 116 ± 3 °C, lower than the failure temperature of the internal router hardware. Case failure did not affect router operation. Nonetheless, precise router case melting temperature was measured via independent experiment. A K-Type thermocouple was affixed with Scotch® tape to the top plate of the router casing, and the plate was baked inside the oven without the router using the same warm-up routine described in the Methods section. The plastic casing was observed to wilt at 116 ± 3 °C and to bubble at 121 ± 3 °C, the result of which can be seen in Figure 3. This failure temperature is consistent with common commercial plastics such as polycarbonate.[10, 11, 12]

Figure 3. Netgear WGT634U Wireless Router after First Oven Bake to 130 °C Showing Visible Deformation and Bubbling of Plastic Casing from Temperature Exposure.

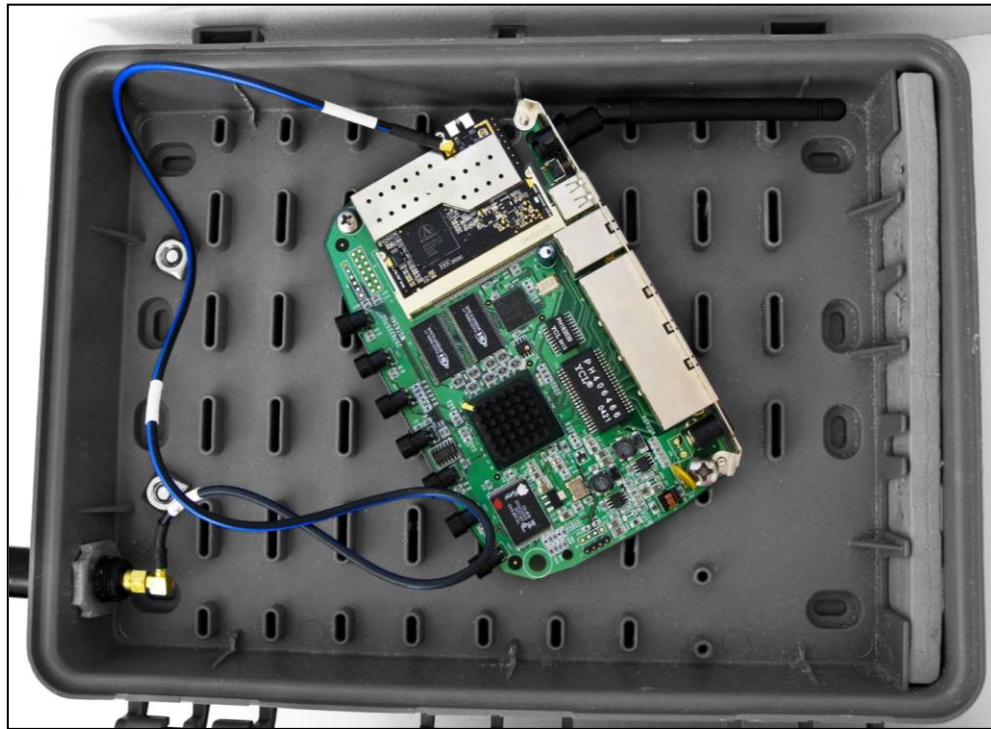
Importantly, Roofnet routers are not placed outside unprotected in the elements. They are well encased in weather-resistant environmental packages (Figure 4) when mounted outside. Could high ambient temperature coupled with internal router heat generation have caused the environmental casing interiors to reach 130 °C? To show how this failure mode might occur, we applied a conductive heat transfer analysis to a router enclosed in a plastic casing. The following assumptions were used. First, the heat transfer is modeled as a one-dimensional process with heat generated at the router being conducted through a lumped thermal resistance to ambient. Second, the router is dissipating 12 watts; according to the router's power supply, nominal power consumption is 12 watts (12 volts at 1 ampere). Third, the router is running right at its thermal shut-off temperature, 130 °C. Fourth, heat is being dissipated to the hottest possible Massachusetts ambient environment, 42 °C. Finally, the heat transfer coefficient between the outer surface of the package and the ambient environment is infinite (in other words, the outer casing surface temperature is a spatially uniform 42 °C). Under these assumptions, the enclosure in which the router is mounted must present an R value of 7.33 K-m^2/W to induce router thermal shut-off.

Figure 4. Netgear WGT634U Router Hardware Shown within a Typical Roofnet Weather-Resistant Environmental Package to Provide a Size Comparison. (Image by Lauren Keville used with permission of Kurt Keville, MIT Roofnet.)
